The Locomotive

THE HARTFORD STEAM BOILER INSPECTION AND INSURANCE CO.

VOL. XXXIV.

INDEX TO VOL. XXXIV.—1922-1923

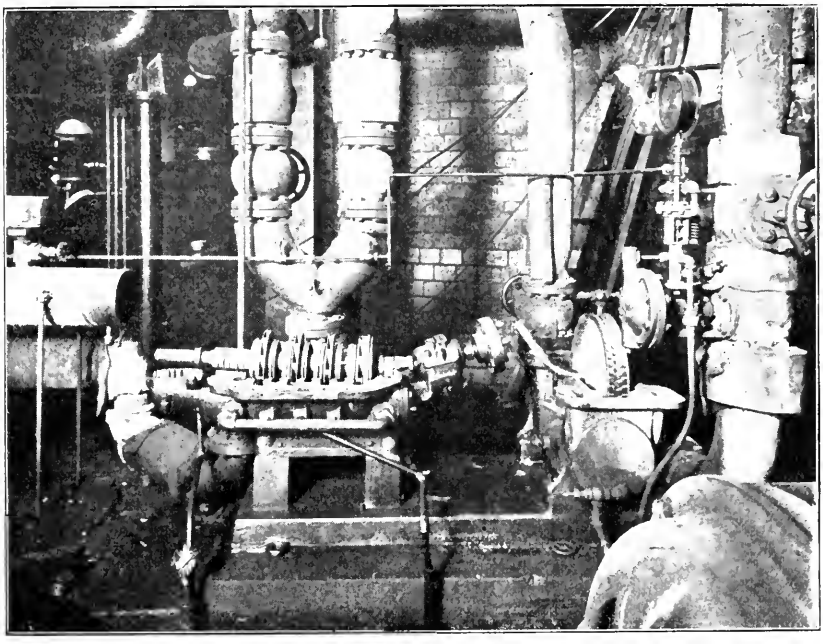
FIG. 1.

On June 12, 1925, a 60 horse-power turbine exploded in the plant of the Pittsfield Electric Co., Pittsfield, Mass. The turbine was direct connected to a boiler feed pump and operated at 2800 r.p.m. The governor, of the usual revolving weight type, was located on the

end of the shaft. The evidence indicates that some part of the governor failed first and thus prevented the governor from functioning properly, finally disrupting it. With no counteracting force, the governor spring immediately opened the regulating valve and allowed the turbine to speed to destruction.

Figure 1 shows how the unit looked after the accident when the debris had been cleared away and the rotor replaced in the casing. The governor end of the shaft, shown in Fig. 2, broke off just beyond the bearing, and the other end of the turbine shaft was bent to an angle of approximately 45 degrees. Both bearings, which had been cast integral with the casing, were broken off, the top half of the casing shattered, and the nozzles torn out of the lower half of the casing. In fact, the turbine was completely wrecked. In addition the flexible coupling burst and considerable damage was also done to the pump, including the bending of the shaft.
